FOND DU LAC RESERVATION TRIP REPORT

Assessment of Mold and Moisture Conditions

Final Report

Date:
May 2, 2003

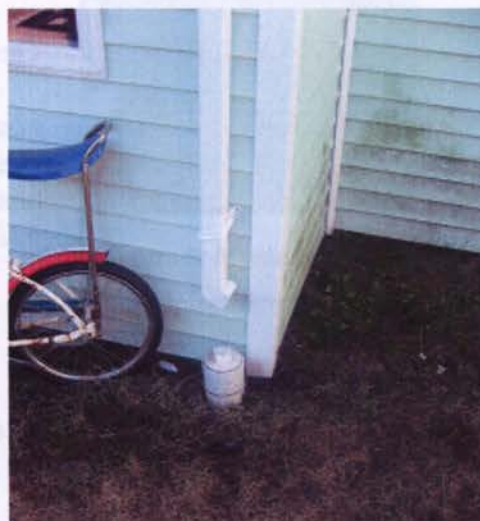
Mold and Moisture Conditions: No mold was on the interior, but mildew grew on the vinyl siding on the north side of the structure, particularly near grade and on the gables (Figure 2).

Figure 2: Downspout draining against building and mildew on siding

1. Regularly clean the mildew from the vinyl siding on the north side of the building. Since the north side does not receive direct sunlight, it stays wet and is therefore susceptible to mildew growth. The wet siding tends to collect dust, allowing mildew to grow.
2. Replace the damaged vinyl siding near the base of the house (Figure 9). Compromised siding increases the potential for water entry into the house and accelerated deterioration.

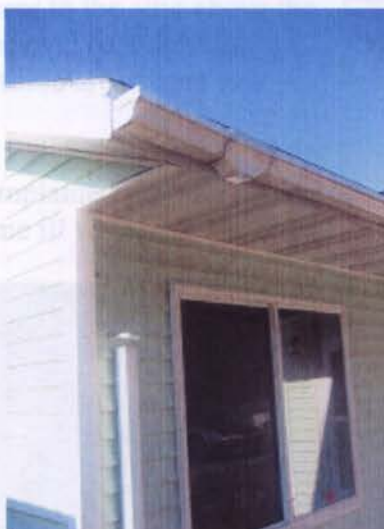
1. It was undersized for the drained roof surface area.
2. Inside corner shields that prevented water off the roof valleys from splashing over the outside edge were missing.
3. Several missing downspouts allowed water to saturate the building (Figures 3 & 4).

Figure 3: Missing downspout

1. Replace gutters with appropriately sized gutters that can accommodate the surface area to be drained.
2. Replace gutters with metal commercial grade gutters.
3. Tie the downspouts into a subsurface drain-tile system to conduct the water away from the building.
4. Implement a gutter maintenance regime needs to be to keep the gutters functioning and clear of debris from nearby trees.
5. Divert the parking lot drainage away from the building.

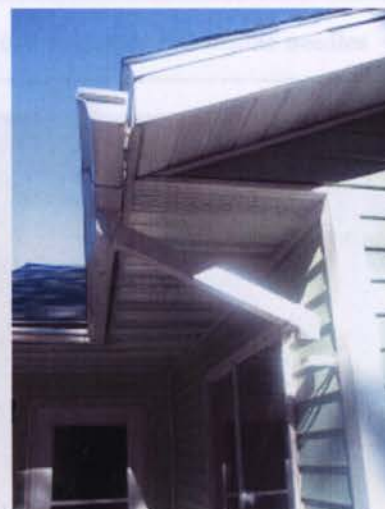
Figure 4: Missing downspout

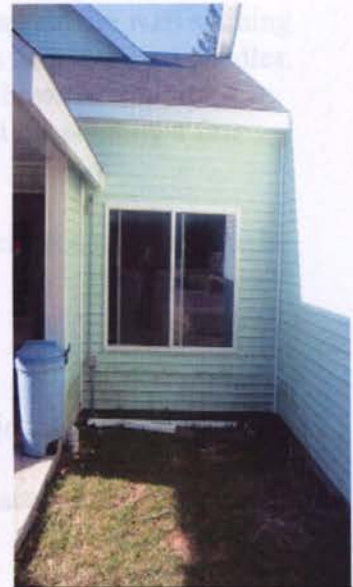
4. One gutter had fallen off the building (Figure 5).
5. Pine needles had accumulated in the gutters (Figure 6).
6. The downspouts drained adjacent to the building rather than being tied into a drain tile.

Figure 5: Missing gutter

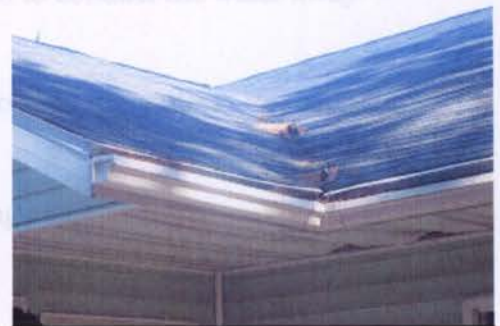
Figure 6: Gutter full w/pine needles

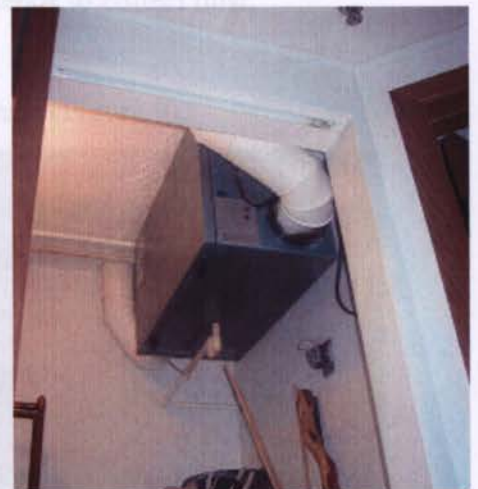
Mechanical Systems: Each unit had a thermostat controlling electric baseboard heating unit and a Heat Recovery Ventilation (HRV) system (Figure 7). The HRV had an intake port in the bathroom and two fresh-air exhaust ports, one near the kitchen and one in the living area. The fresh air intake and exhaust for the HRV was supposedly located in a roof monitor that was not inspected due to the inaccessibility of the attic space.

Figure 7: Air-to-air heat exchanger

5. Maintenance staff should regularly inspect and replace HRV filters.
6. Since the air-to-air heat exchangers draw moisture-laden air out of the bathroom, it is likely that considerable condensation occurs on the heat exchanger surfaces during winter months. Periodic inspect condensate drains for clogs, mold growth, or overflow into the closets.

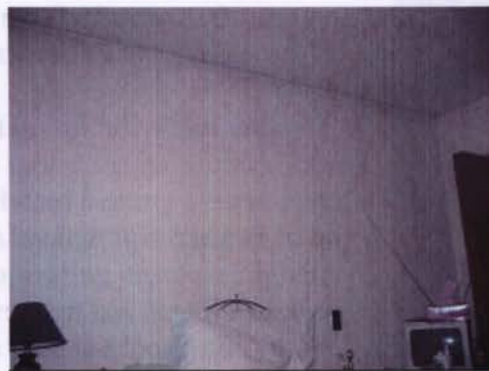
Figure 8: Staining on walls in bedroom

smoker and also liked to burn candles. The inspection team suspected the wall staining was primarily environmental tobacco smoke and carbon deposits from burning candles. Further investigation could verify these preliminary conclusions however the fire department came to the same conclusions when they investigated the staining a few months ago.

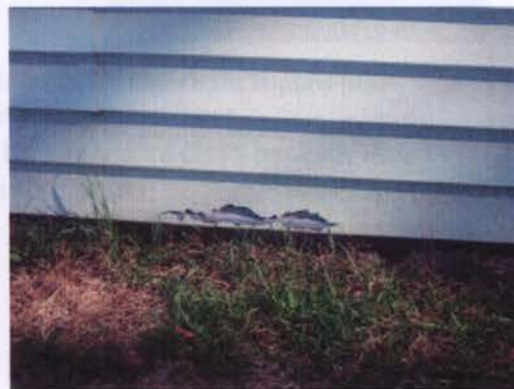
8. Cracked vinyl siding – both the Sawyer Elderly Center and one house with vinyl siding had cracks or holes through the vinyl siding. Clearly, any violation of the siding will allow air and moisture into the wall system.

Figure 9: Damaged vinyl siding

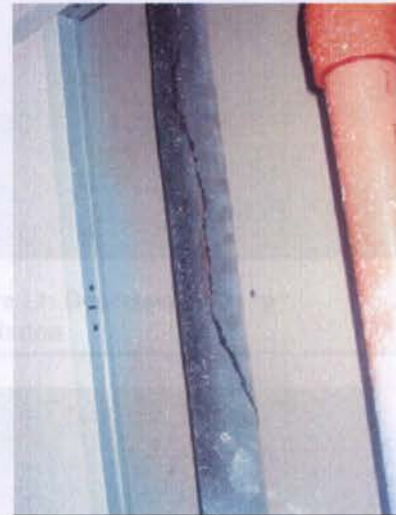
Figure 10: Ripped pipe insulation

2. Inspect and thoroughly insulate all piping. Pipe insulation on cold water supply lines was poorly installed. Condensation occurs on exposed elbows, tees, and other areas where insulation is missing or ripped (Figure 10 & 11). The condensation drips onto ceiling tiles and other building surfaces, saturating and deteriorating the surfaces, and providing moisture for mold growth.

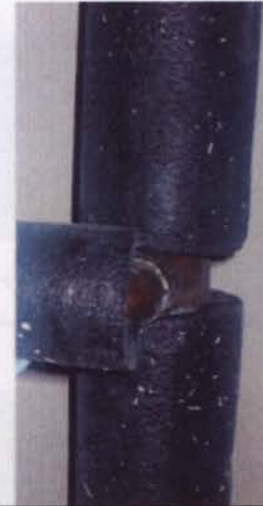
Figure 11: Exposed plumbing elbow

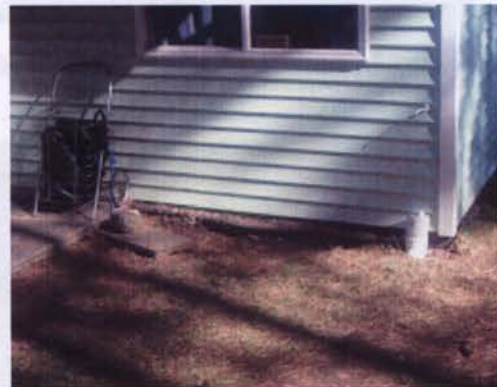
Figure 12: Depression next to foundation

5. A depression in the soil was visible on the south side of the building near the east end (Figure 12). Fill in these depressions, since they channel water toward the building which can wet the concrete slab and consequently draw the moisture up into the structure through capillary action.

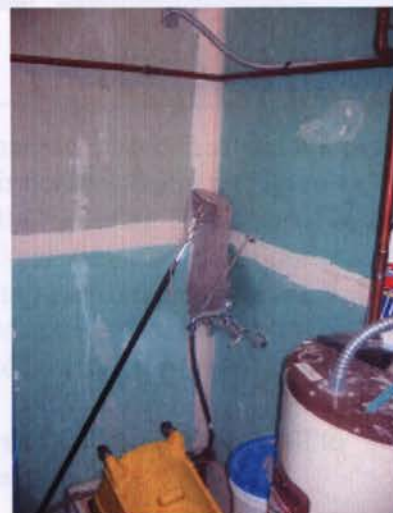
6. A wet-mop leaned on the drywall above the mop sink in the utility/janitor closet (Figure 13). This practice will allow mold to grow and the drywall to deteriorate. Allow the drywall to dry and then glue Fiber Reinforced Plastic (FRP) to the drywall. Health codes in many communities require the installation of FRP sheeting around mop sinks.

Figure 13: Mop against drywall

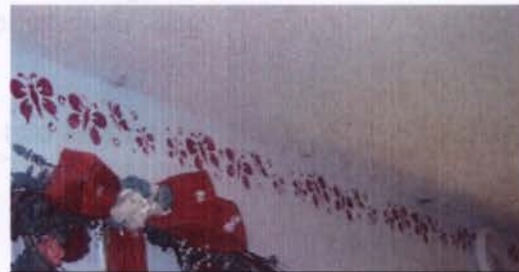
Mold and Moisture Conditions: This home had minor mold growth at the wall to ceiling junction (Figure 2).

Figure 2: Mold at wall to ceiling junction

Exterior Wall/Ceiling Junction: The living and dining areas had mold at the wall to ceiling junction. The mold grew where a truss rested on the top plates.

2. Insulate the upper two feet of the foundation walls with 2" of rigid insulation to resolve the water condensation problem on the wall.
3. The staircase sidewalls appear to have standard lumber resting directly on the basement slab (Figure 9). Any wood coming in direct contact with concrete should be pressure treated lumber. When these plates deteriorate, replace them with pressure treated lumber.
4. Although the attic appeared to have approximately 10" to 12" of blown-in insulation, increase the insulation at the perimeter of the attic.

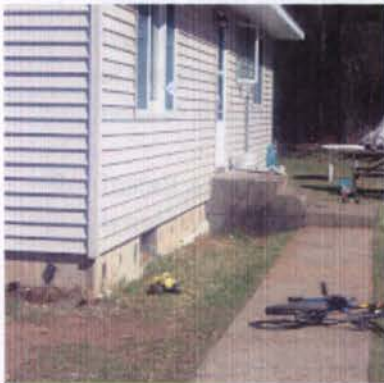
Rainwater Management: Although the site had the potential for drainage away from the house, the grade at the back of the house sloped toward the residence (Figure 3). There were no gutters on the house.

Figure 3: Grade slopes towards house

1. Install front and back gutters with leaders directing the water away from the house. This would especially help at the rear of the house where the water currently sheds next to the house and drains back toward the foundation.
2. Install a window well around the rear basement window, add fill material, and recontour the grade to drain water away from the house.
3. Fix the dryer exhaust vent that separated from the wall and replace the existing duct tape with appropriate duct sealing materials.
4. Fix the cracked vinyl siding.

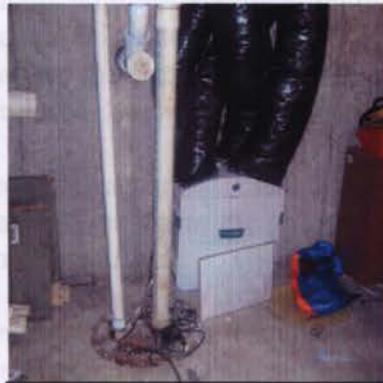
Figure 4: HRV & ejector pit

Basement Conditions: The occupant stated that the basement had been fairly damp, but conditions had improved with the installation of an air-to-air heat exchanger, (Figure 4). Mold was growing in one upper corner of the basement wall (Figure 5). This growth was not unexpected since this area of the wall was not insulated and was exposed to exterior conditions. Mold is growing on the foundation walls on the top section, since this area would be the coldest and the first area where water would condense on the wall. The rest of the foundation wall was below grade and had 2" rigid insulation next to it.

1. The residents kept a very neat home which helped prevent and reduce mold growth.
2. The occupant did not know how to operate the HRV control panel. Educate the resident on the purpose, operation, and maintenance of the HRV system.
3. Although the windows were replaced recently, they already showed signs of deterioration due to condensation on the glass saturating the lower portion of each sash (Figure 10). The residents should try the following:
 - a. Ventilate the house whenever there is an excessive amount of moisture on the interior,
 - b. Run the HRV more often or at a higher rate at times of high humidity, or
 - c. Buy a dehumidifier to remove the excessive moisture.

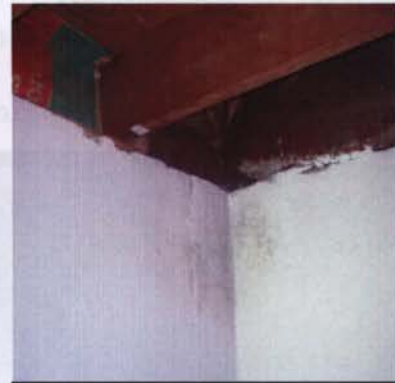
Figure 5: Mold on basement walls

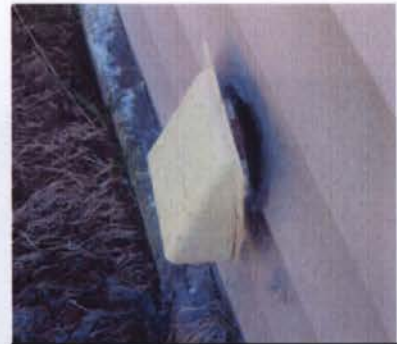
Exterior Siding: The home had vinyl siding installed over old plywood siding. The dryer vent was disconnected from the duct on the exterior of the structure (Figure 6). One piece of siding directly below the exterior water spigot had a crack in it (Figure 7). Staining appeared on the siding beneath the spigot, indicating a leak (Figure 7).

Figure 6: Disconnected drier vent

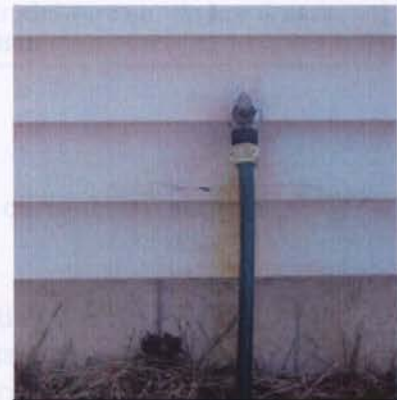
Figure 7: Cracked siding w/evidence of plumbing leak

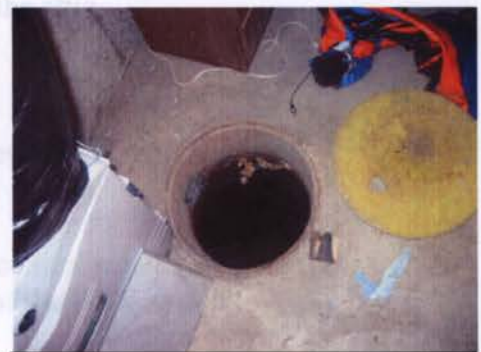
Figure 8: Sump pit w/o sump pump

1. The existing sump pit did not have a sump pump (Figure 8). Install a sump pump that drains away from the house.

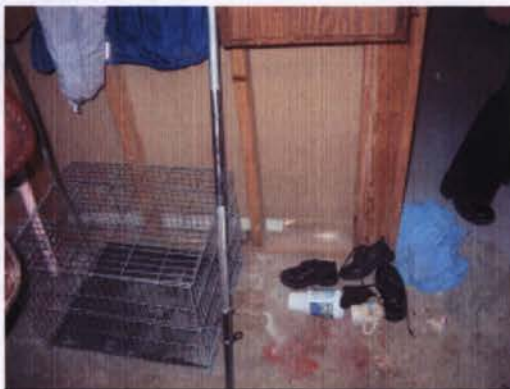
Figure 9: Standard lumber in direct contact w/concrete

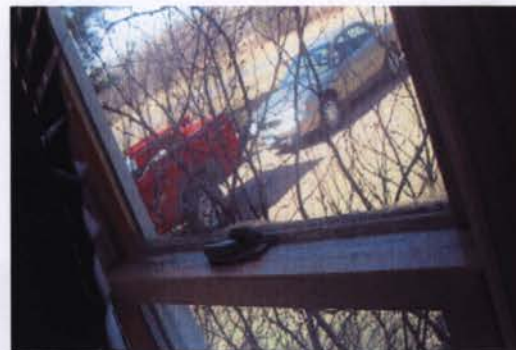
Figure 10: Moisture on window & sash deterioration

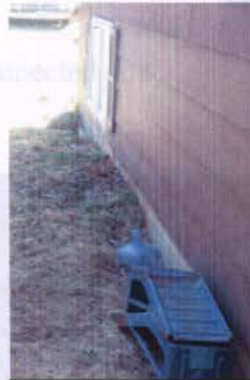
Rainwater Management: The site was relatively flat. There were no gutters on the house except for short front and back door sections. Depressions next to the foundation were probably due to animal activity (Figure 2).

Figure 2:
Depressions next
to foundation

3. Fix the missing dryer exhaust vent (Figure 10).
4. Fill in the depressions next to the foundation, grade away from the structure and replant with grass.

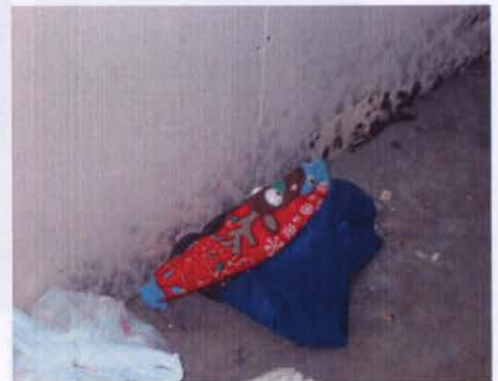
Lower Level Conditions: The lower level of this structure was approximately three and one-half feet underground. The hallway and bedroom were carpeted; the bathroom had vinyl tile; and the rest of the basement floors were exposed concrete. The hallway carpet was wet and squishy when walked on. According to the occupant, the septic system backed-up regularly flooding the basement. The area surrounding the floor drain had bits of toilet paper stuck to the floor from previous flooding events. The drywall at the base of the wall close to this area become saturated from flooding events and was currently growing mold (Figure 3).

Figure 3: Mold at base of bsmt. wall

1. Remove all carpeting from the lower level and thoroughly clean the entire slab. Resurface the hallway and bedroom with vinyl, composite tile, or sheet goods. Use washable throw rugs in the bedroom.
2. Fix all plumbing leaks.
3. Repair, or if necessary, replace damaged drywall in both bathrooms.
4. Reconnect the dryer vent.
5. Seal unused penetrations through the exterior walls.
6. Repair or replace the door from the dining room to the exterior.
7. Remove all moldy drywall, clean all exposed surfaces, and replace where necessary. Keep the drywall from coming into direct contact with the concrete slab.

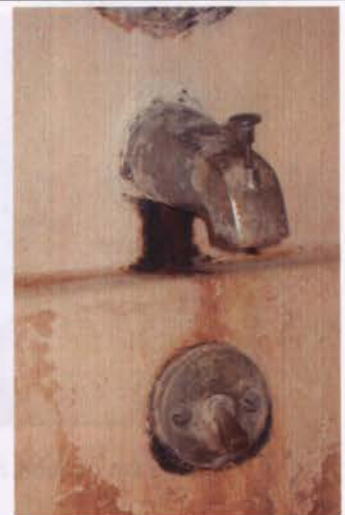
1. The spigot in the tub leaked with mold growing beneath it (Figure 4).
2. The upper corner above the tub, against the exterior wall, had mold growth (Figure 5).

Figure 4: Mold at the
basement tub's spigot

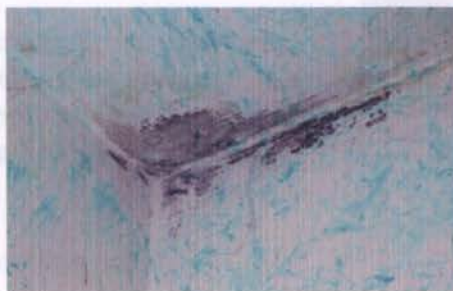
Figure 5: Corner above tub

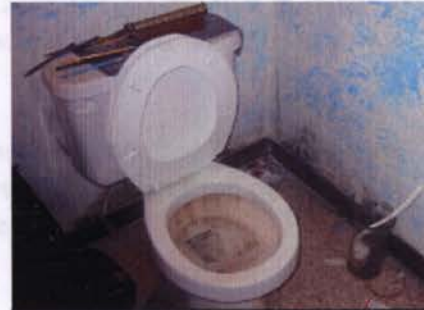
3. The drywall above the toilet was missing due to a leak in the bathroom above.
4. Mold grew around the base of the walls around the toilet (Figure 6).

Figure 6: Mold at base of wall

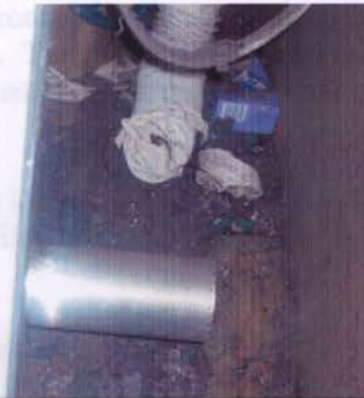
1. The clothes dryer vent was disconnected and vented to the interior (Figure 7).
2. Two penetrations through the walls did not connect to anything (Figure 8). One allows air to flow directly into the interior and the other, a former dryer vent was stuffed with insulation.
3. The lower level bedroom window was partially below grade and the window well grade was directly at the base of the window (Figure 9).

Figure 7: Disconnected drier vent

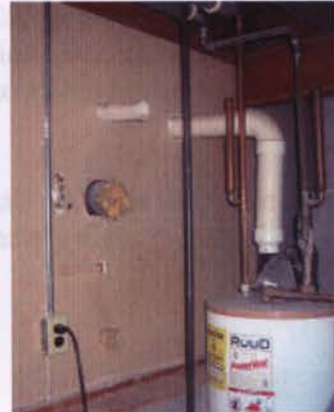
Figure 8: Unattached vents

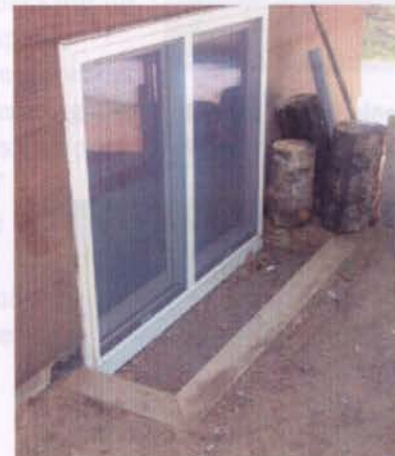
Figure 9: Shallow window well

2. Dig out the area around the lower level windows and install drainage tile, rock and a window well. Only fill the well to within approximately eight inches of the sill of the window.

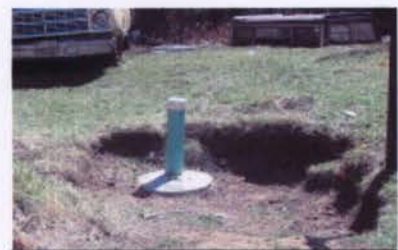
Figure 11: Septic tank lid

5. Fix the septic system. Unquestionably, raw sewage backing up into the residence was the largest problem. The occupant stated that currently the septic had to be emptied once a week to prevent back up. This indicated an improperly operating septic system. Without critical analysis, investigators can only speculate as to what the problem may be. The top of the septic system was clearly evident in the backyard (Figure 11). The resident mentioned that the septic system had been worked on several months earlier and had never been properly backfilled. This is part of the problem. A septic system exposed to cold Northern Minnesota climate could freeze and prevent sewage drainage into or out of the system, causing it to back up. If the system continues to back-up once the ground thaws, the system probably has a clogged leach field.
